**Flood Control Project Maintenance  
Levee Inspections**

## Maintenance Issue Types Only, Levee Inspection Report By Mile - Spring 2019

### Reclamation District No. 0003 Grand Island

Waterway	Bank	Unit Miles	Inspection Start/End	Inspector
Unit No. 01 Left Bank Steamboat Slough	Left	10.95	04/03/2019 04/03/2019	David Julian

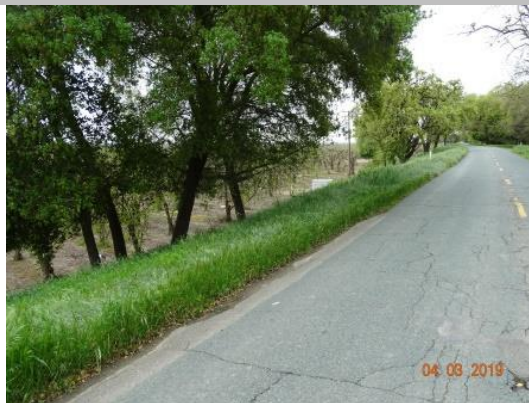
Photo 1 of 1 : SP\_2019\_RD0003\_24\_80\_20190403\_00167.jpg

LM Start	0.00	Rating **	M	Issue No.	80
LM End	2.26	Issue Type +	Ma	Location *	LS
Category	Earthen Levee			GPS Latitude/Longitude	
				Start	End
Item	Vegetation			38.304005 °	38.275925 °
				-121.574313 °	-121.589973 °
DWR ID	DWR_RD0003_01_s_2019_80				
Comment Code					
V1 : Control annual grass and weeds on the levee slopes and easements.					
Inspector Comment					
The LMA needs to maintain annual vegetation.

View looking downstream at vegetation on the landside slope (Spring 2019).

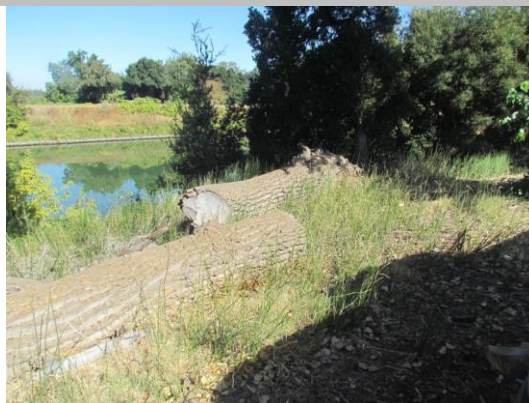
Photo 1 of 2 : SP\_2019\_RD0003\_24\_19\_20190311\_00017.jpg

LM Start	0.13	Rating **	M	Issue No.	19
LM End	0.13	Issue Type +	Ma	Location *	WS
Category	Earthen Levee			GPS Latitude/Longitude	
				Start	End
Item	Encroachments			38.303305 °	38.303305 °
				-121.576537 °	-121.576537 °
DWR ID	DWR_RD0003_01_f_2012_19				
Comment Code					
TR : Tree or limb					
Inspector Comment					
Tree branches and limbs are located on waterward shoulder.

Looking north at tree branches on waterward slope. (Fall 2016)

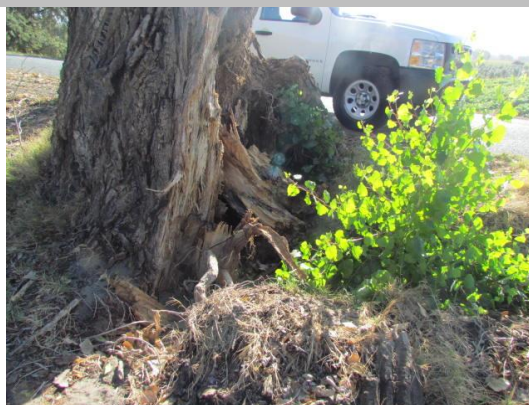
Photo 2 of 3 : SP\_2019\_RD0003\_24\_2\_20190311\_00002.jpg

LM Start	0.13	Rating **	M	Issue No.	2	
LM End	0.13	Issue Type +	Ma	Location *	WS	
Category	Earthen Levee			GPS Latitude/Longitude		
				Start		End
Item	Erosion / Bank Caving			38.303303°	38.303303°	
				-121.576538°	-121.576538°	
DWR ID	DWR_RD0003_01_f_2013_2					
Comment Code						
E2 : Schedule repair of erosion site prior to the next inspection.						
Inspector Comment						
A hole (8ft x 2.5ft x 5ft) is next to a large tree on waterward shoulder.

Looking at a hole next to oak tree on waterward shoulder. (2015)

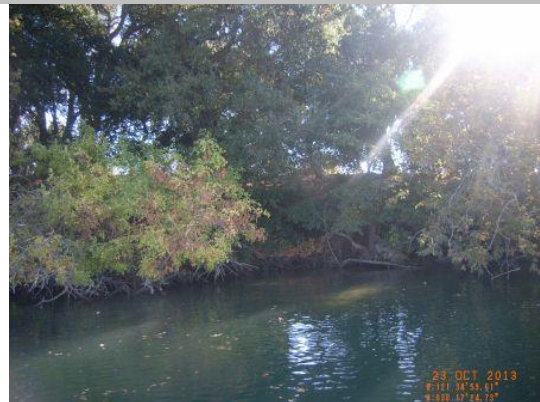
Photo 1 of 2 : SP\_2019\_RD0003\_24\_56\_20190311\_00041.jpg

LM Start	1.03	Rating **	U	Issue No.	56
LM End	1.18	Issue Type +	Ma	Location *	WS
Category	Supplemental			GPS Latitude/Longitude	
				Start	End
Item	2017 USACE Erosion Survey, DRAFT			38.291695 °	38.289575 °
				-121.582993 °	-121.583092 °
DWR ID	DWR_RD0003_01_f_2018_56				
Comment Code					
Inspector Comment					
2017 Site ID: STM 24.8 L					
Status: Eroding					
2018: Pockets of erosion that are deep into the levee toe that I would consider critical (Djulian).					
2017 Field Notes: New erosion at toe.					
Site History: 2008 - Area closed sign on bank. Newly fallen trees at both ends and pop outs along the bank. 2010 - Site extended downstream. 2011 - New erosion at the toe. More trees popouts. 2013 - Short vertical sections observed at the downstream end.

USACE 2013 Photo #1

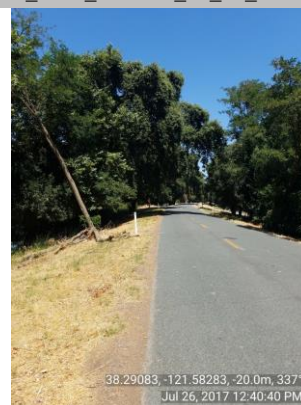
Photo 3 of 3 : SP\_2019\_RD0003\_24\_60\_20190311\_00048.jpg

LM Start	1.09	Rating **	A/W	Issue No.	60 (cont)	
LM End	1.10	Issue Type +	Ma	Location *		
Category	Supplemental			GPS Latitude/Longitude		
				Start	End	
Item	2017 Storm Damage			38.290819 °	38.290706 °	
				-121.582942 °	-121.582939 °	
DWR ID	DWR_RD0003_01_f _ 2017_60					
Comment Code						
Inspector Comment						
Levee Evaluation Comments						
Description:District station 57+57 to 57+98, Sec. 18, 1. 5 N. R. 4 E., M.D.M. An erosion site exists along approximately 41 linear feet of the water side slope of Steamboat Slough (Unit 1). The erosion commences approximately 1/2 of the way down the slope from the crown to the waterside toe.						
Site ID No:276						
Site Designation:LMA-102						
Repair Type: Erosion						
Rating:Area of Concern						
Field Date:7/26/2017						
Notes:

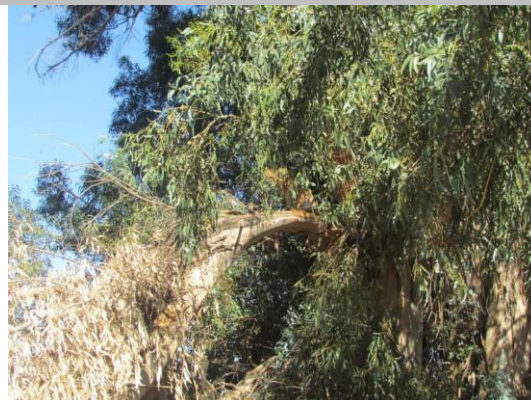
Photo 2 of 2 : SP\_2019\_RD0003\_24\_62\_20190311\_00050.jpg

LM Start	1.69	Rating **	M	Issue No.	62
LM End	1.69	Issue Type +	Ma	Location *	WS
Category	Earthen Levee			GPS Latitude/Longitude	
				Start	End
Item	Encroachments			38.283747 °	38.283747 °
				-121.587622 °	-121.587622 °
DWR ID	DWR_RD0003_01_f_2016_62				
Comment Code					
TR : Tree or limb					
Inspector Comment					
There is a broken tree branch on the waterward slope.

Looking southwest at broken branches on waterward slope.

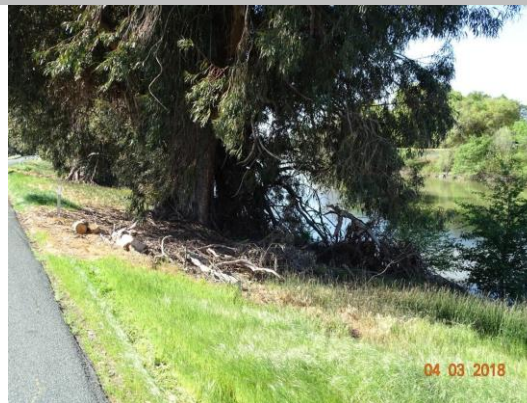
Photo 1 of 1 : SP\_2019\_RD0003\_24\_54\_20190311\_00039.jpg

LM Start	1.91	Rating **	M	Issue No.	54
LM End	1.91	Issue Type +	Ma	Location *	WS
Category	Earthen Levee			GPS Latitude/Longitude	
				Start	End
Item	Encroachments			38.280638 °	38.280638 °
				-121.588457 °	-121.588457 °
DWR ID	DWR_RD0003_01_s_2018_54				
Comment Code					
TR : Tree or limb					
Inspector Comment					
Remove tree trimmings from the waterside slope.

Cut branches on waterside slope.

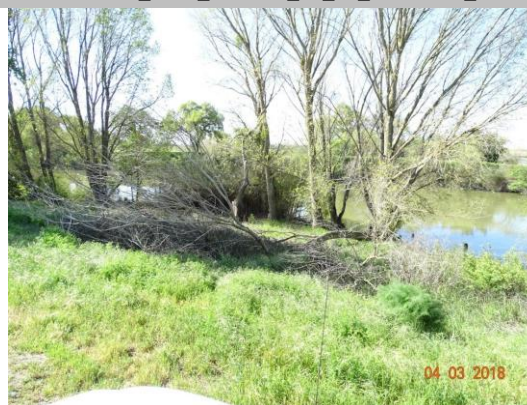
Photo 1 of 1 : SP\_2019\_RD0003\_24\_55\_20190311\_00040.jpg

LM Start	2.27	Rating **	M	Issue No.	55
LM End	2.27	Issue Type +	Ma	Location *	WS
Category	Earthen Levee			GPS Latitude/Longitude	
				Start	End
Item	Encroachments			38.275827 °	38.275827 °
				-121.589979 °	-121.589979 °
DWR ID	DWR_RD0003_01_s_2018_55				
Comment Code					
TR : Tree or limb					
Inspector Comment					
There is a fallen tree on the waterside slope.

Fallen tree limb on waterside.

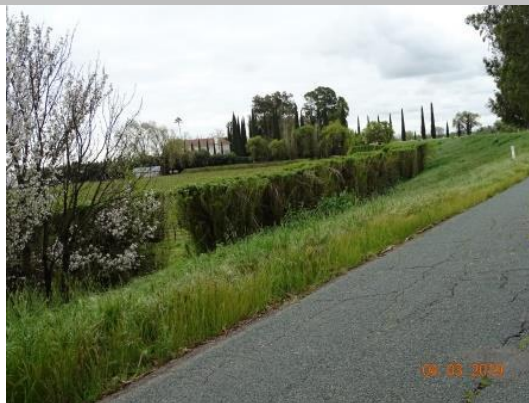
Photo 1 of 1 : SP\_2019\_RD0003\_24\_109\_20190403\_00171.jpg

LM Start	2.57	Rating **	M	Issue No.	109
LM End	10.60	Issue Type +	Ma	Location *	LS
Category	Earthen Levee			GPS Latitude/Longitude	
				Start	End
Item	Vegetation			38.272316 °	38.184120 °
				-121.588024 °	-121.647614 °
DWR ID	DWR_RD0003_01_s_2019_109				
Comment Code					
V1 : Control annual grass and weeds on the levee slopes and easements.					
Inspector Comment					
Maintain annual vegetation.

View looking downstream at annual vegetation on the landside slope (Spring 2019).

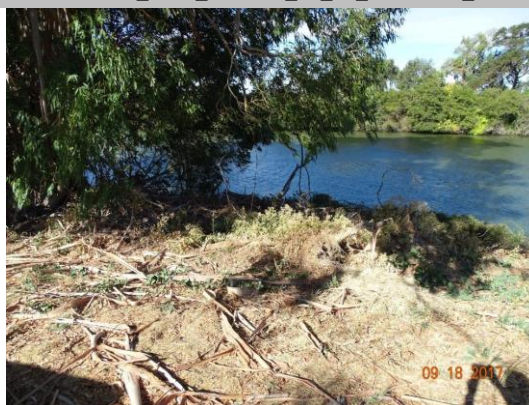
Photo 1 of 1 : SP\_2019\_RD0003\_24\_82\_20190311\_00075.jpg

LM Start	2.66	Rating **	M	Issue No.	82
LM End	2.66	Issue Type +	Ma	Location *	WS
Category	Earthen Levee			GPS Latitude/Longitude	
				Start	End
Item	Encroachments			38.271128 °	38.271128 °
				-121.588634 °	-121.588634 °
DWR ID	DWR_RD0003_01_f_2017_82				
Comment Code					
TR : Tree or limb					
Inspector Comment					
Tree limbs should be removed from the waterside slope.

Looking southwest at waterside slope.

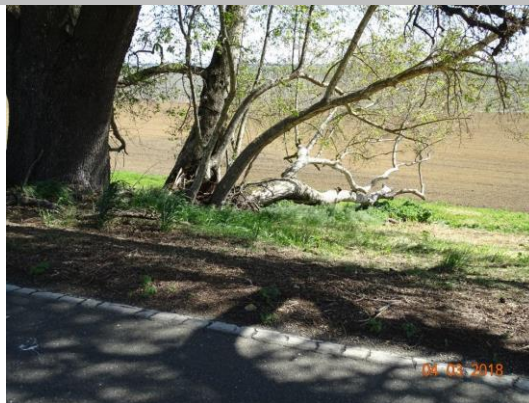
Photo 2 of 2 : SP\_2019\_RD0003\_24\_63\_20190311\_00052.jpg

LM Start	5.65	Rating **	M	Issue No.	63 (cont)	
LM End	5.65	Issue Type +	Ma	Location *	LS	
Category	Earthen Levee			GPS Latitude/Longitude		
				Start		End
Item	Trim / Thin Trees			38.234721 °		38.234721 °
				-121.601709 °		-121.601709 °
DWR ID	DWR_RD0003_01_f_2016_63					
Comment Code						
T1 : Trim trees to at least five feet above ground level.						
Inspector Comment						
Trim the growth from the tree so that the levee slope can be seen.

Low-lying tree limb should be removed from landside slope.

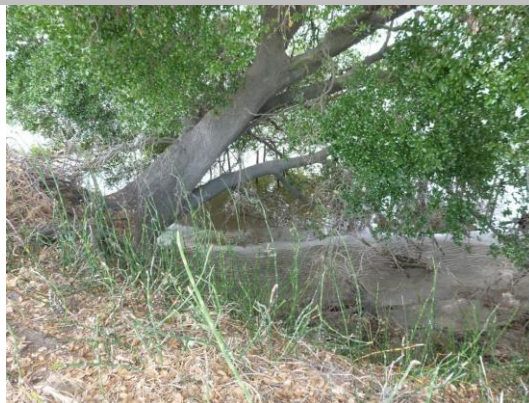
Photo 1 of 3 : SP\_2019\_RD0003\_24\_73\_20190311\_00063.jpg

LM Start	10.67	Rating **	A/W	Issue No.	73	
LM End	10.92	Issue Type +	Ma	Location *		
Category	Supplemental			GPS Latitude/Longitude		
				Start	End	
Item	2017 Storm Damage			38.183810 °	38.182480 °	
				-121.648780 °	-121.653150 °	
DWR ID	DWR_RD0003_01_f_2017_73					
Comment Code						
Inspector Comment						
Levee Evaluation Comments						
Description:						
Site ID No:63						
Site Designation:DWR_RD0003_01_R_2012_03						
Repair Type: Erosion						
Rating:Serious						
Field Date:6/8/2017						
Notes: scattered erosion scarps caving into levee crown, within erosion limit crown width ranges from 15 to 30', several trees with exposed tree roots and leaning into the river.

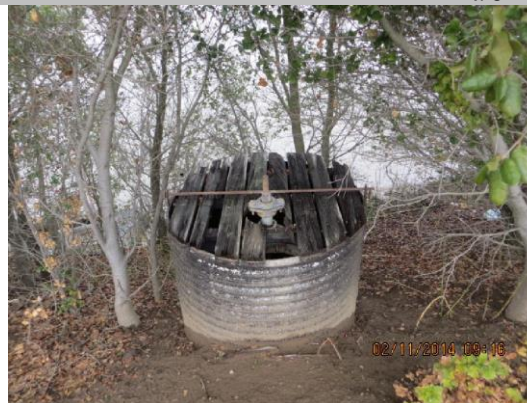
Photo 2 of 3 : UCIP\_SP\_2019\_29165\_53865.jpg

Item	DWR UCIP LMA Responsibility			38.182982 °		38.182982 °
				-121.651610 °		-121.651610 °
DWR ID	22206					
Comment Code						
Inspector Comment						
FS_ID:29165 DS_ID:22206 EP_NO: N/A Repair Type: Non-Urgent Crossing Status: Found UCIP Comments: Pipe appears abandoned and should be verified as having been done so properly. FIELD_STRUCT_DESC: *ABANDONED* 1 of 3: 36-inch corrugated metal drainage pipe through the levee, 15 feet below the crown. Slide gate in a 48-inch corrugated metal pipe (CMP) riser on the waterside (WS) shoulder. Flap gate at the WS toe has been sealed shut with sealant. [Additional Reference(s): DWR Levee Log, 1993, referenced as 24 feet below the crown. USACE Sacramento O&M Manual 104, February 1960, (RM 15.20), referenced as invert elevation 24 feet below the crown]. FS Date: 2/11/2014

Slide gate in 48-inch CMP riser on WS shoulder.

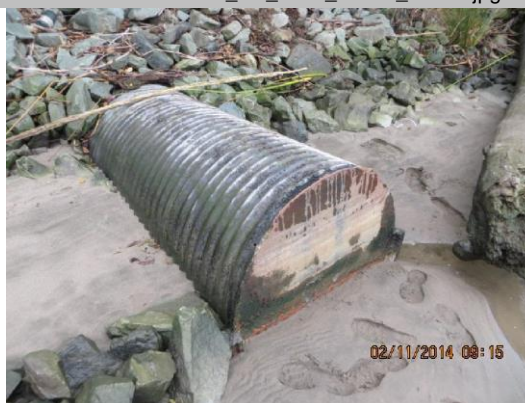
Photo 1 of 3 : UCIP\_SP\_2019\_29164\_53862.jpg

Comment Code					
Inspector Comment					
FS_ID:29164					
DS_ID:22349					
EP_NO: N/A					
Repair Type: Non-Urgent					
Crossing Status: Found					
UCIP Comments: Pipe appears abandoned and should be verified as having been filled with grout.					
FIELD_STRUCT_DESC: *ABANDONED* 2 of 3: 36-inch corrugated metal drainage pipe through the levee, 15 feet below the crown. Slide gate in a 48-inch corrugated metal pipe (CMP) riser on the waterside (WS) shoulder. Steel intake weir at the landside (LS) toe. Steel plate welded over the pipe on the WS toe. [Additional Reference(s): DWR Levee Log, 1993, referenced as 24 feet below the crown. USACE Sacramento O&M Manual 104, February 1960, (RM 15.20), referenced as invert elevation 24 feet below the crown].					
FS Date: 2/11/2014

Drainpipe visible on WS toe with steel plate welded over end.

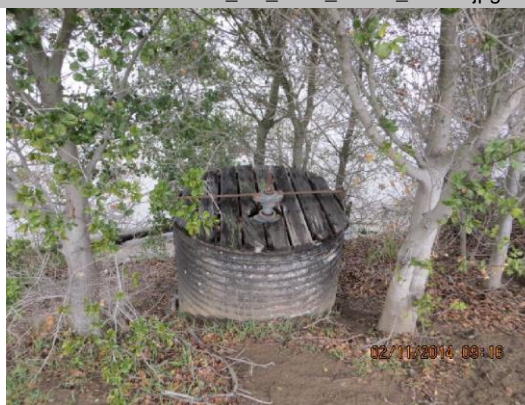
Photo 2 of 3 : UCIP\_SP\_2019\_29164\_53861.jpg

48-inch CMP riser with slide gate closed on WS shoulder.

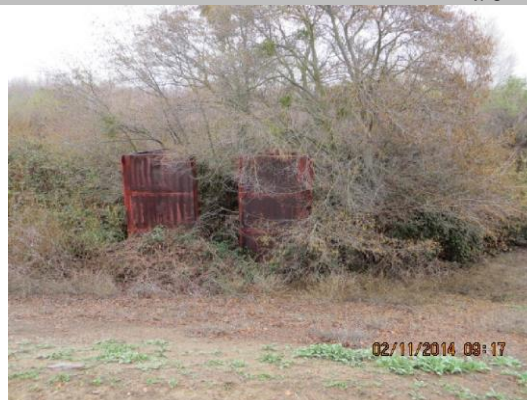
Photo 3 of 3 : UCIP\_SP\_2019\_29164\_53860.jpg

Item	DWR UCIP LMA Responsibility			38.182973 °	38.182973 °	
				-121.651645 °	-121.651645 °	
DWR ID	22349					
Comment Code						
Inspector Comment						
FS_ID:29164						
DS_ID:22349						
EP_NO: N/A						
Repair Type: Non-Urgent						
Crossing Status: Found						
UCIP Comments: Pipe appears abandoned and should be verified as having been filled with grout.						
FIELD_STRUCT_DESC: *ABANDONED* 2 of 3: 36-inch corrugated metal drainage pipe through the levee, 15 feet below the crown. Slide gate in a 48-inch corrugated metal pipe (CMP) riser on the waterside (WS) shoulder. Steel intake weir at the landside (LS) toe. Steel plate welded over the pipe on the WS toe. [Additional Reference(s): DWR Levee Log, 1993, referenced as 24 feet below the crown. USACE Sacramento O&M Manual 104, February 1960, (RM 15.20), referenced as invert elevation 24 feet below the crown].						
FS Date: 2/11/2014

Steel weir on LS toe.

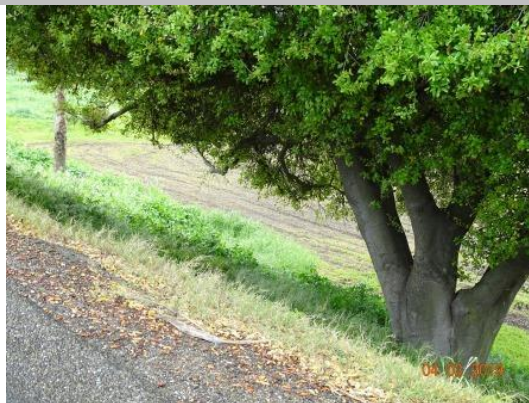
Photo 1 of 1 : SP\_2019\_RD0003\_25\_193\_20190404\_00337.jpg

LM Start	0.00	Rating **	M	Issue No.	193	
LM End	9.01	Issue Type +	Ma	Location *	LS	
Category	Earthen Levee			GPS Latitude/Longitude		
				Start		End
Item	Vegetation				°	38.236764 °
					°	-121.559424 °
DWR ID	DWR_RD0003_02_s_2019_193					
Comment Code						
V1 : Control annual grass and weeds on the levee slopes and easements.						
Inspector Comment						
Maintain annual vegetation.

View looking downstream at annual vegetation on the landside slope (Spring 2019).

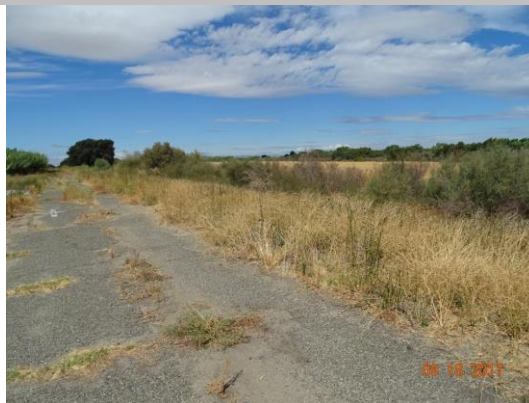
Photo 1 of 2 : SP\_2019\_RD0003\_25\_151\_20190311\_00128.jpg

LM Start	0.31	Rating **	U	Issue No.	151
LM End	0.35	Issue Type +	Ma	Location *	LS
Category	Earthen Levee			GPS Latitude/Longitude	
				Start	End
Item	Vegetation			38.174235 °	38.174109 °
				-121.648479 °	-121.647870 °
DWR ID	DWR_RD0003_02_s_2016_151				
Comment Code					
V2 : Remove the wild growth other than native grasses from the levee slopes.					
Inspector Comment					
Remove young willows along landside toe.

Looking west at landside slope.

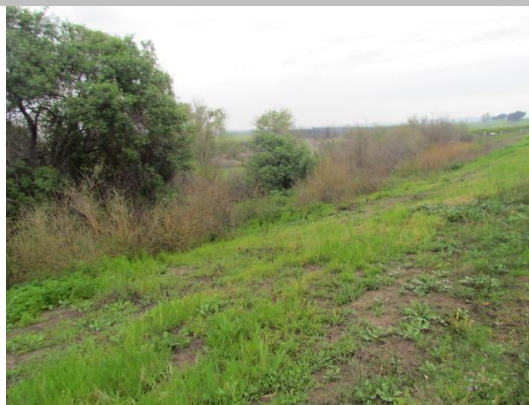
Photo 2 of 2 : SP\_2019\_RD0003\_25\_151\_20190311\_00129.jpg

Looking west at dense vegetation at landward toe.

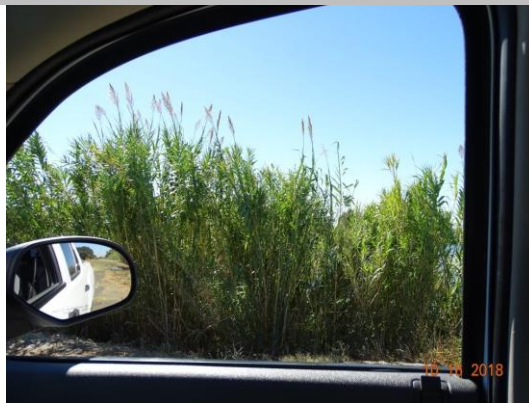
Photo 1 of 1 : SP\_2019\_RD0003\_25\_3\_20190311\_00004.jpg

LM Start	0.37	Rating **	U	Issue No.	3
LM End	0.37	Issue Type +	Ma	Location *	WS
Category	Earthen Levee			GPS Latitude/Longitude	
				Start	End
Item	Vegetation			38.174020°	38.174020°
				-121.647458°	-121.647458°
DWR ID	DWR_RD0003_02_f_2018_3				
Comment Code					
V2 : Remove the wild growth other than native grasses from the levee slopes.					
Inspector Comment					
Remove arundo from waterside slope.

View of arundo on waterside slope (October 2018).

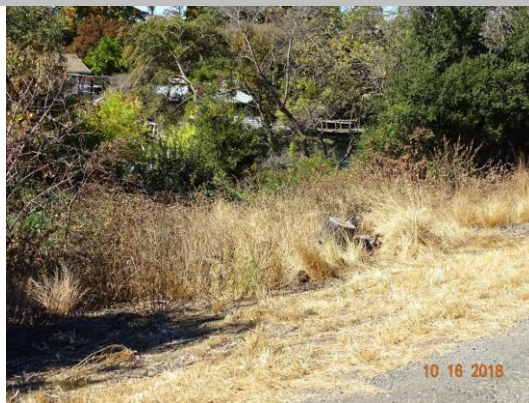
Photo 1 of 3 : SP\_2019\_RD0003\_25\_129\_20190311\_00091.jpg

LM Start	1.57	Rating **	M	Issue No.	129
LM End	1.57	Issue Type +	Ma	Location *	WS
Category	Earthen Levee			GPS Latitude/Longitude	
				Start	End
Item	Encroachments			38.168700 °	38.168700 °
				-121.627233 °	-121.627233 °
DWR ID	DWR_RD0003_02_s_2017_129				
Comment Code					
TR : Tree or limb					
Inspector Comment					
Remove remaining branches and stump of downed tree from the waterside slope.

View of tree limbs that have mostly been removed from waterside slope (October 2018).

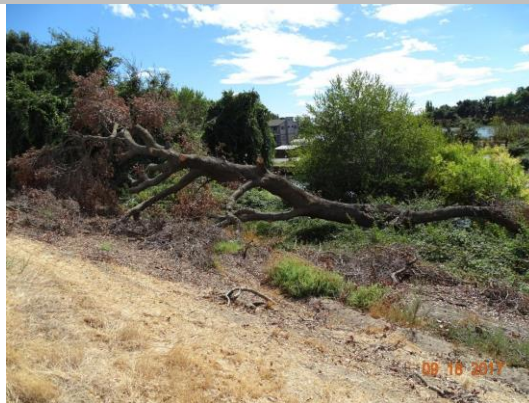
Photo 2 of 3 : SP\_2019\_RD0003\_25\_129\_20190311\_00092.jpg

Looking east at waterside slope.

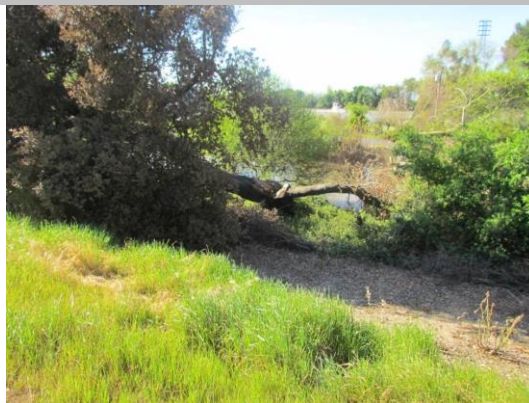
Photo 3 of 3 : SP\_2019\_RD0003\_25\_129\_20190311\_00093.jpg

Looking east at fallen tree on waterward slope.

LM Start	1.57	Rating **	M	Issue No.	129 (cont)	
LM End	1.57	Issue Type +	Ma	Location *	WS	
Category	Earthen Levee			GPS Latitude/Longitude		
				Start		End
Item	Encroachments			38.168700 °		38.168700 °
				-121.627233 °		-121.627233 °
DWR ID	DWR_RD0003_02_s_2017_129					
Comment Code						
TR : Tree or limb						
Inspector Comment						
Remove remaining branches and stump of downed tree from the waterside slope.

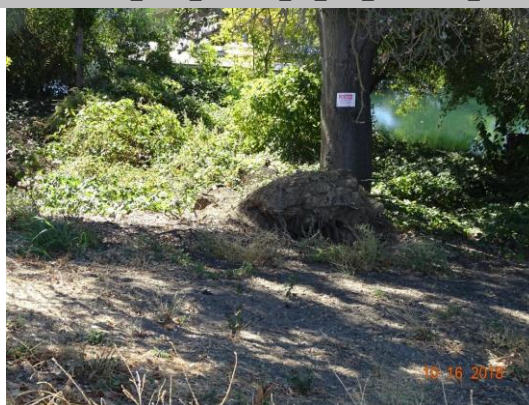
Photo 1 of 3 : SP\_2019\_RD0003\_25\_130\_20190311\_00094.jpg

View of fallen tree on waterside slope that has almost been completely removed (October 2018).

LM Start	1.67	Rating **	M	Issue No.	130
LM End	1.67	Issue Type +	Ma	Location *	WS
Category	Earthen Levee			GPS Latitude/Longitude	
				Start	End
Item	Encroachments			38.167880 °	38.167880 °
				-121.625572 °	-121.625572 °
DWR ID	DWR_RD0003_02_s_2017_130				
Comment Code					
TR : Tree or limb					
Inspector Comment					
Remove remaining stump and branches from waterside slope.

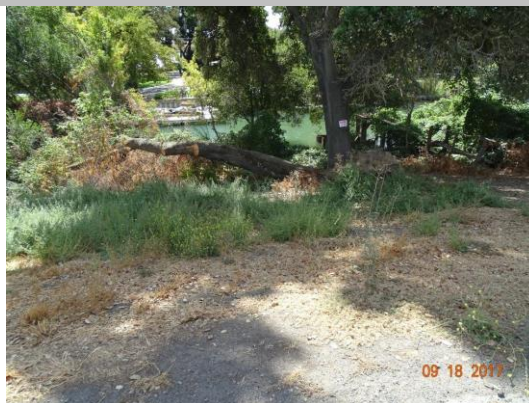
Photo 2 of 3 : SP\_2019\_RD0003\_25\_130\_20190311\_00095.jpg

Looking south at the waterside slope.

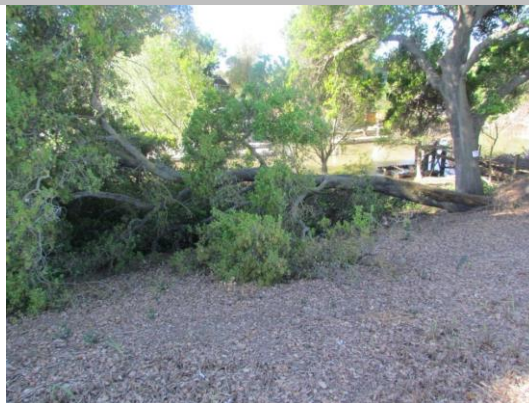
Photo 3 of 3 : SP\_2019\_RD0003\_25\_130\_20190311\_00096.jpg

Looking south at fallen tree on waterward slope.

LM Start	1.67	Rating **	M	Issue No.	130 (cont)	
LM End	1.67	Issue Type +	Ma	Location *	WS	
Category	Earthen Levee			GPS Latitude/Longitude		
				Start		End
Item	Encroachments			38.167880 °		38.167880 °
				-121.625572 °		-121.625572 °
DWR ID	DWR_RD0003_02_s_2017_130					
Comment Code						
TR : Tree or limb						
Inspector Comment						
Remove remaining stump and branches from waterside slope.

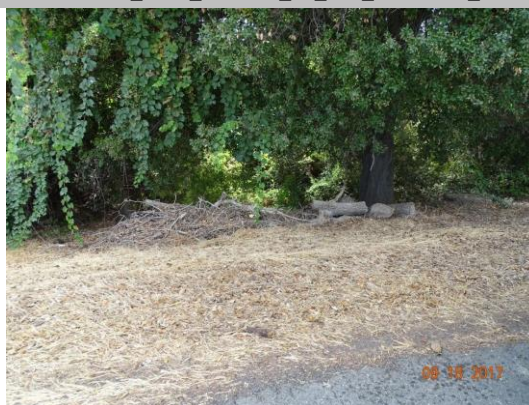
Photo 1 of 2 : SP\_2019\_RD0003\_25\_140\_20190311\_00110.jpg

Looking south at the waterside slope.

LM Start	2.01	Rating **	M	Issue No.	140
LM End	2.01	Issue Type +	Ma	Location *	WS
Category	Earthen Levee			GPS Latitude/Longitude	
				Start	End
Item	Encroachments			38.165740 °	38.165740 °
				-121.619970 °	-121.619970 °
DWR ID	DWR_RD0003_02_f_2015_140				
Comment Code					
PR : Prunings					
Inspector Comment					
Remove pruning pile on waterside slope.

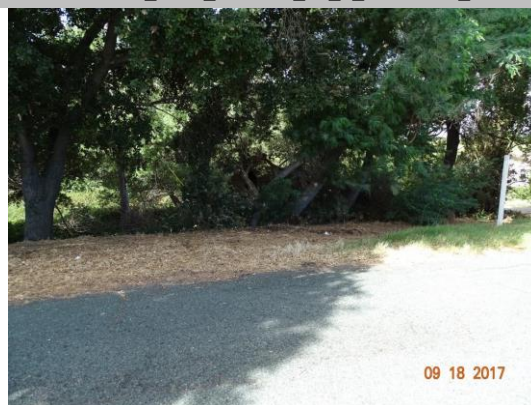
Photo 1 of 2 : SP\_2019\_RD0003\_25\_7\_20190311\_00007.jpg

LM Start	3.20	Rating **	M	Issue No.	7
LM End	3.20	Issue Type +	Ma	Location *	LS
Category	Earthen Levee			GPS Latitude/Longitude	
				Start	End
Item	Trim / Thin Trees			38.167808 °	38.167808 °
				-121.599557 °	-121.599557 °
DWR ID	DWR_RD0003_02_s_2012_7				
Comment Code					
T1 : Trim trees to at least five feet above ground level.					
Inspector Comment					
There is dense vegetation on the landside slope and toe.

Looking northwest at the landside slope.

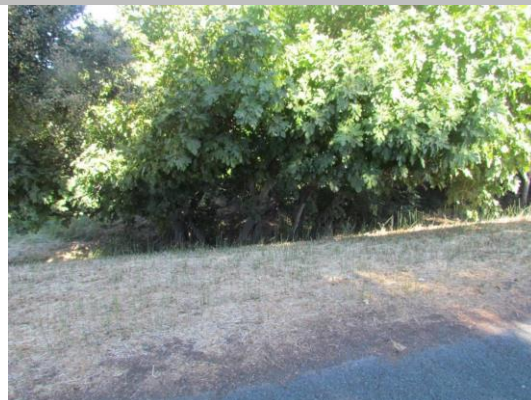
Photo 2 of 2 : SP\_2019\_RD0003\_25\_7\_20190311\_00008.jpg

Looking north at fig tree at landward toe.

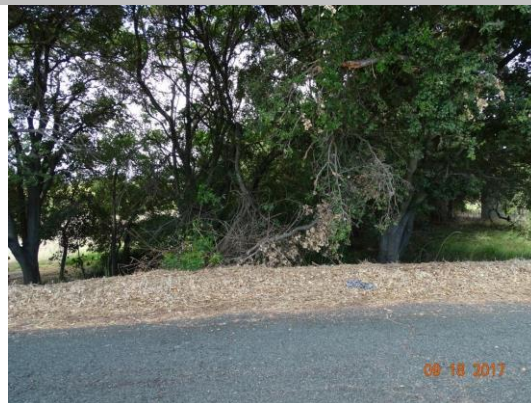
Photo 1 of 1 : SP\_2019\_RD0003\_25\_154\_20190311\_00134.jpg

LM Start	3.30	Rating **	U	Issue No.	154
LM End	3.30	Issue Type +	Ma	Location *	LS
Category	Earthen Levee			GPS Latitude/Longitude	
				Start	End
Item	Encroachments			38.168750 °	38.168750 °
				-121.598152 °	-121.598152 °
DWR ID	DWR_RD0003_02_f_2017_154				
Comment Code					
TR : Tree or limb					
Inspector Comment					
There is a downed tree on the landside slope.

Looking northwest at the landside slope.

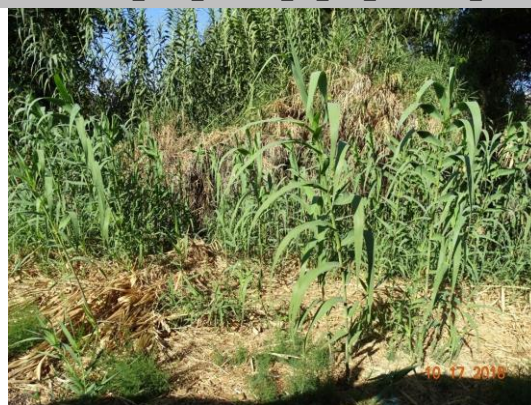
Photo 1 of 1 : SP\_2019\_RD0003\_25\_200\_20190311\_00157.jpg

View of new arundo growth on the landside slope (October 2018).

LM Start	3.78	Rating **	U	Issue No.	200
LM End	3.78	Issue Type +	Ma	Location *	LS
Category	Earthen Levee			GPS Latitude/Longitude	
				Start	End
Item	Vegetation			38.174550 °	38.174550 °
				-121.593345 °	-121.593345 °
DWR ID	DWR_RD0003_02_f_2018_200				
Comment Code					
V2 : Remove the wild growth other than native grasses from the levee slopes.					
Inspector Comment					
Remove the new arundo growth.

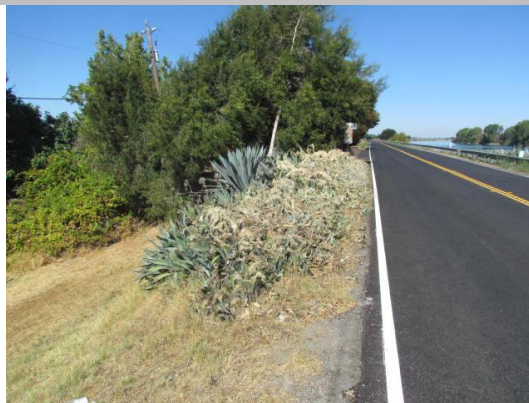
Photo 1 of 1 : SP\_2019\_RD0003\_25\_143\_20190311\_00115.jpg

LM Start	4.11	Rating **	U	Issue No.	143
LM End	4.11	Issue Type +	Ma	Location *	LS
Category	Earthen Levee			GPS Latitude/Longitude	
				Start	End
Item	Vegetation			38.178782 °	38.178782 °
				-121.590418 °	-121.590418 °
DWR ID	DWR_RD0003_02_f_2015_143				
Comment Code					
V7 : Trees / Woody Vegetation					
Inspector Comment					
There are large century plants on the landside shoulder and slope.

Looking north at century plants on landward shoulder and slope.

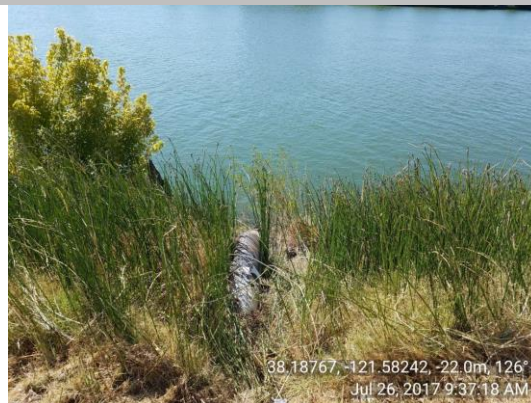
Photo 1 of 3 : SP\_2019\_RD0003\_25\_127\_20190311\_00087.jpg

LM Start	4.86	Rating **	A/W	Issue No.	127
LM End	4.87	Issue Type +	Ma	Location *	
Category	Supplemental			GPS Latitude/Longitude	
				Start	End
Item	2017 Storm Damage			38.187528 °	38.187781 °
				-121.582394 °	-121.582331 °
DWR ID	DWR_RD0003_02_f_2017_127				
Comment Code					
Inspector Comment					
Levee Evaluation Comments					
Description:District station 256+60 to 257+96, Sec. 19, T. 4 N. R. 4 E., M.D.M. Approximately 136 linear feet erosion and sloughing exists along the water side slope of the Sacramento River (Unit 2). The erosion commences approximately 1/4 of the way down the slope from the crown and extends to the rip rap.					
Site ID No:278					
Site Designation:LMA-104					
Repair Type: Erosion					
Rating:Area of Concern					
Field Date:7/26/2017					
Notes:

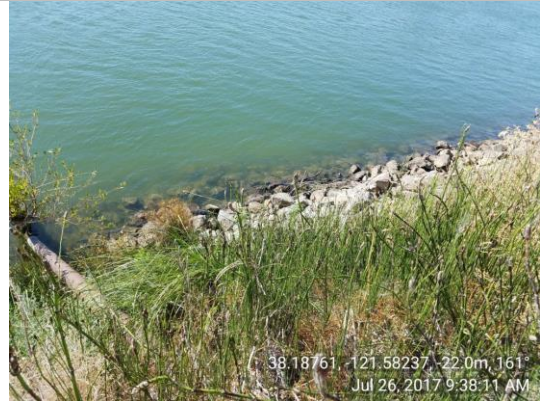
Photo 3 of 3 : SP\_2019\_RD0003\_25\_127\_20190311\_00089.jpg

LM Start	4.86	Rating **	A/W	Issue No.	127 (cont)	
LM End	4.87	Issue Type +	Ma	Location *		
Category	Supplemental			GPS Latitude/Longitude		
				Start	End	
Item	2017 Storm Damage			38.187528 °	38.187781 °	
				-121.582394 °	-121.582331 °	
DWR ID	DWR_RD0003_02_f_2017_127					
Comment Code						
Inspector Comment						
Levee Evaluation Comments						
Description: District station 256+60 to 257+96, Sec. 19, T. 4 N. R. 4 E., M.D.M. Approximately 136 linear feet erosion and sloughing exists along the water side slope of the Sacramento River (Unit 2). The erosion commences approximately 1/4 of the way down the slope from the crown and extends to the rip rap.						
Site ID No: 278						
Site Designation: LMA-104						
Repair Type: Erosion						
Rating: Area of Concern						
Field Date: 7/26/2017						
Notes:

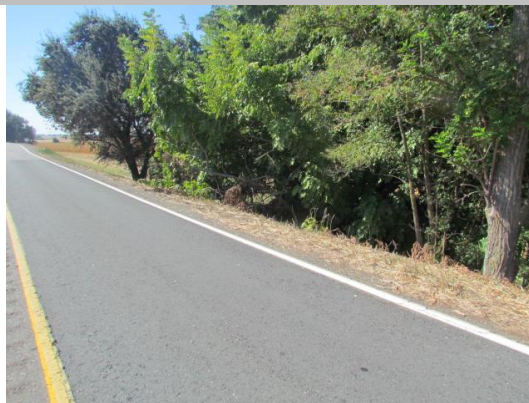
Photo 2 of 2 : SP\_2019\_RD0003\_25\_14\_20190311\_00017.jpg

LM Start	4.94	Rating **	M	Issue No.	14 (cont)	
LM End	4.98	Issue Type +	Ma	Location *	LS	
Category	Earthen Levee			GPS Latitude/Longitude		
				Start		End
Item	Trim / Thin Trees			38.188344 °		38.188748 °
				-121.581414 °		-121.580743 °
DWR ID	DWR_RD0003_02_s_2012_14					
Comment Code						
T1 : Trim trees to at least five feet above ground level.						
Inspector Comment						
There are untrimmed trees on the landside slope and toe.

Looking southwest at untrimmed trees on landward toe. (Spring 2016)

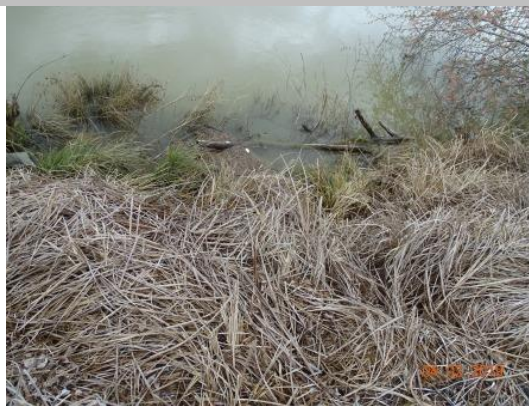
Photo 1 of 1 : SP\_2019\_RD0003\_25\_194\_20190404\_00317.jpg

LM Start	4.94	Rating **	A/W	Issue No.	194
LM End	4.94	Issue Type +	Ma	Location *	WS
Category	Earthen Levee			GPS Latitude/Longitude	
				Start	End
Item	Erosion / Bank Caving			38.188248 °	-121.581225 °
				38.188248 °	-121.581225 °
DWR ID	DWR_RD0003_02_s_2019_194				
Comment Code					
E1 : Note and monitor erosion site.					
Inspector Comment					
Rip rap is not as visible at this location. Inspect location when vegetation is less dense in the fall.

View looking downslope at potential erosion on the waterside slope (Spring 2019).

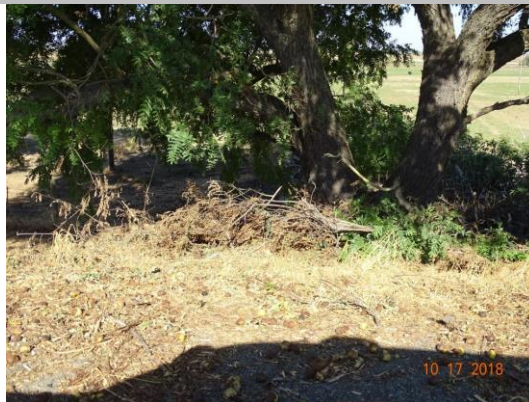
Photo 1 of 1 : SP\_2019\_RD0003\_25\_56\_20190311\_00039.jpg

View of tree limbs on the landside slope (October 2018).

LM Start	5.03	Rating **	M	Issue No.	56
LM End	5.03	Issue Type +	Ma	Location *	LS
Category	Earthen Levee			GPS Latitude/Longitude	
				Start	End
Item	Encroachments			38.189227 °	38.189227 °
				-121.579983 °	-121.579983 °
DWR ID	DWR_RD0003_02_f_2018_56				
Comment Code					
TR : Tree or limb					
Inspector Comment					
Remove tree limbs on landside slope.

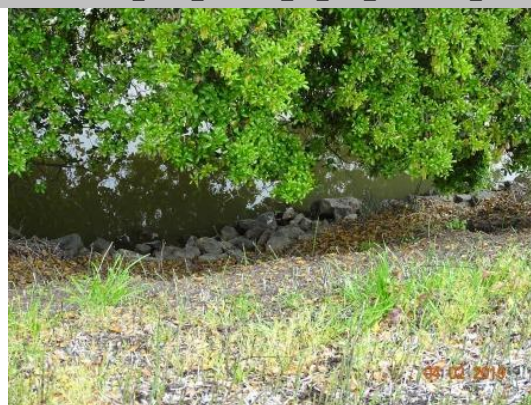
Photo 1 of 1 : SP\_2019\_RD0003\_25\_196\_20190404\_00318.jpg

LM Start	8.67	Rating **	M	Issue No.	196
LM End	8.67	Issue Type +	Ma	Location *	WS
Category	Earthen Levee			GPS Latitude/Longitude	
				Start	End
Item	Erosion / Bank Caving			38.232066 °	-121.558586 °
				38.232066 °	-121.558586 °
DWR ID	DWR_RD0003_02_s_2019_196				
Comment Code					
E1 : Note and monitor erosion site.					
Inspector Comment					
There is a bench on the waterside slope.

View looking downslope at erosion on the waterside slope (Spring 2019).

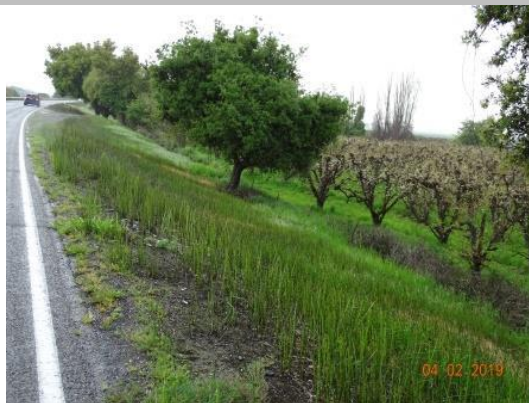
Photo 1 of 1 : SP\_2019\_RD0003\_25\_184\_20190404\_00334.jpg

View looking downstream at annual vegetation on the landside slope (Spring 2019).

LM Start	9.19	Rating **	U	Issue No.	184
LM End	10.73	Issue Type +	Ma	Location *	LS
Category	Earthen Levee			GPS Latitude/Longitude	
				Start	End
Item	Vegetation			38.239175 °	38.238799 °
				-121.557848 °	-121.531847 °
DWR ID	DWR_RD0003_02_s_2019_184				
Comment Code					
V1 : Control annual grass and weeds on the levee slopes and easements.					
Inspector Comment					
Control annual vegetation.

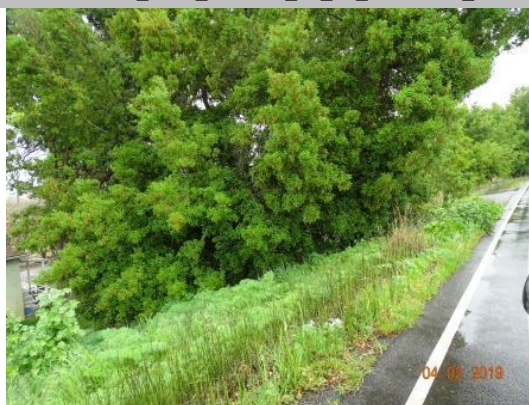
Photo 1 of 1 : SP\_2019\_RD0003\_25\_63\_20190404\_00320.jpg

View looking upstream at thick trees on the landside slope (Spring 2019).

LM Start	9.29	Rating **	U	Issue No.	63
LM End	9.29	Issue Type +	Ma	Location *	LS
Category	Earthen Levee			GPS Latitude/Longitude	
				Start	End
Item	Trim / Thin Trees			38.240337 °	38.240337 °
				-121.556870 °	-121.556870 °
DWR ID	DWR_RD0003_02_s_2012_63				
Comment Code					
T1 : Trim trees to at least five feet above ground level.					
Inspector Comment					
Trim trees on the landside slope.

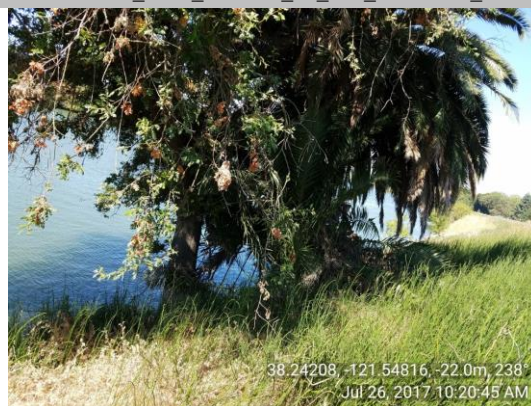
Photo 1 of 3 : SP\_2019\_RD0003\_25\_137\_20190311\_00101.jpg

LM Start	9.82	Rating **	A/W	Issue No.	137
LM End	9.84	Issue Type +	Ma	Location *	
Category	Supplemental			GPS Latitude/Longitude	
				Start	End
Item	2017 Storm Damage			38.242006 °	38.241950 °
				-121.548117 °	-121.547681 °
DWR ID	DWR_RD0003_02_s_2019_137				
Comment Code					
Inspector Comment					
Levee Evaluation Comments					
Description:District station 518+55 to 519+81 , Sec. 33, T. 5 N. R. 4 E., M.D.M. Approximately 126 linear feet of erosion and sloughing exists along the water side slope of the Sacramento River (Unit 2). The erosion commences approximately 1/4 of the way down the slope from the crown and extends into the rip rap.					
Site ID No:279					
Site Designation:LMA-105					
Repair Type: Erosion					
Rating:Area of Concern					
Field Date:7/26/2017					
Notes:

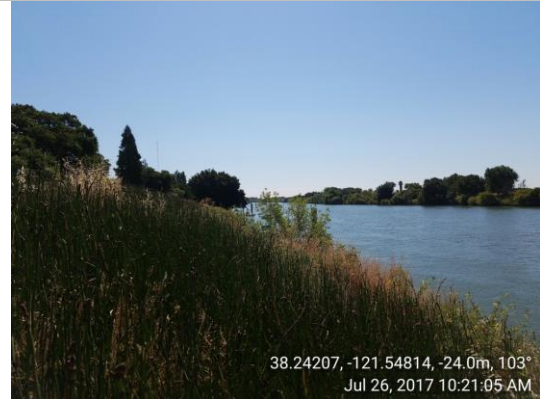
Photo 3 of 3 : SP\_2019\_RD0003\_25\_137\_20190311\_00103.jpg

LM Start	9.82	Rating **	A/W	Issue No.	137 (cont)	
LM End	9.84	Issue Type +	Ma	Location *		
Category	Supplemental			GPS Latitude/Longitude		
				Start	End	
Item	2017 Storm Damage			38.242006 °	38.241950 °	
				-121.548117 °	-121.547681 °	
DWR ID	DWR_RD0003_02_s_2019_137					
Comment Code						
Inspector Comment						
Levee Evaluation Comments						
Description:District station 518+55 to 519+81 , Sec. 33, T. 5 N. R. 4 E., M.D.M. Approximately 126 linear feet of erosion and sloughing exists along the water side slope of the Sacramento River (Unit 2). The erosion commences approximately 1/4 of the way down the slope from the crown and extends into the rip rap.						
Site ID No:279						
Site Designation:LMA-105						
Repair Type: Erosion						
Rating:Area of Concern						
Field Date:7/26/2017						
Notes:

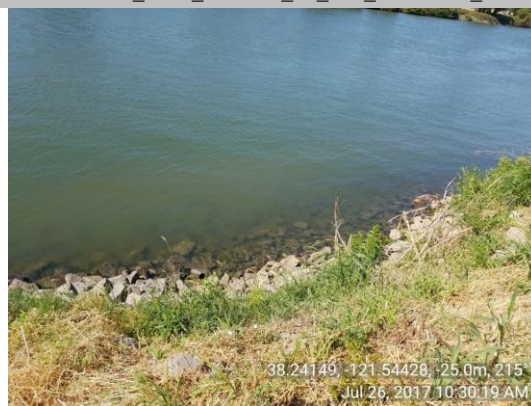
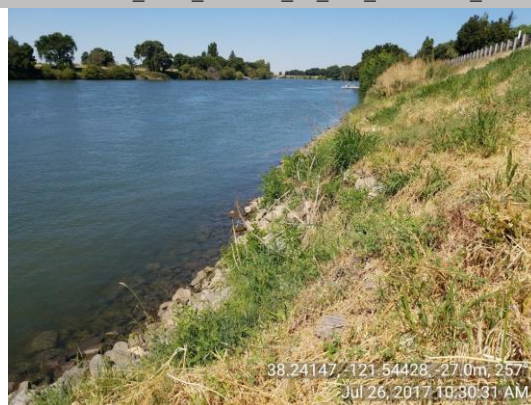
LM Start	10.01	Rating **	A/W	Issue No.	138 (cont)	
LM End	10.03	Issue Type +	Ma	Location *		
Category	Supplemental			GPS Latitude/Longitude		
				Start	End	
Item	2017 Storm Damage			38.241481 °	38.241439 °	
				-121.544569 °	-121.544353 °	
DWR ID	DWR_RD0003_02_f_2017_138					
Comment Code						
Inspector Comment						
Levee Evaluation Comments						
Description: District station 528+97 to 529+58, Sec. 33, T. 5 N. R. 4 E., M.D.M. Approximately 61 linear feet of erosion and sloughing exists along the water side slope of the Sacramento River (Unit 2). The erosion commences approximately 1/2 of the way down the slope from the crown and extends into the rip rap.						
Site ID No: 280						
Site Designation: LMA-106						
Repair Type: Erosion						
Rating: Area of Concern						
Field Date: 7/26/2017						
Notes:

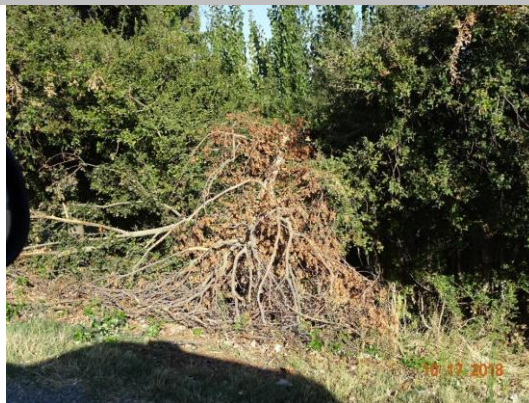
Photo 1 of 1 : SP\_2019\_RD0003\_25\_163\_20190311\_00139.jpg

LM Start	10.99	Rating **	M	Issue No.	163
LM End	10.99	Issue Type +	Ma	Location *	LS
Category	Earthen Levee			GPS Latitude/Longitude	
				Start	End
Item	Encroachments			38.239377 °	38.239377 °
				-121.527177 °	-121.527177 °
DWR ID	DWR_RD0003_02_f_2018_163				
Comment Code					
TR : Tree or limb					
Inspector Comment					
Remove dead branch from the landside slope.

View of dead branch on landside slope (October 2018).

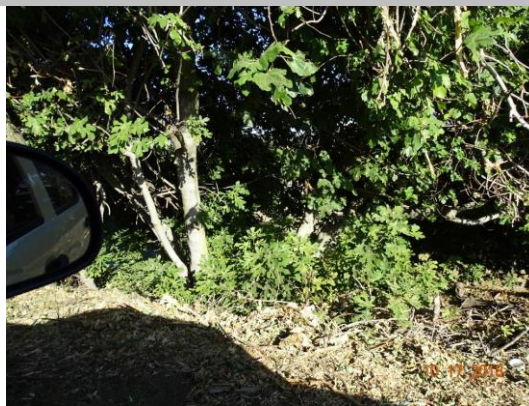
Photo 1 of 1 : SP\_2019\_RD0003\_25\_148\_20190311\_00122.jpg

LM Start	11.21	Rating **	U	Issue No.	148
LM End	11.21	Issue Type +	Ma	Location *	LS
Category	Earthen Levee			GPS Latitude/Longitude	
				Start	End
Item	Trim / Thin Trees			38.239968 °	38.239968 °
				-121.523293 °	-121.523293 °
DWR ID	DWR_RD0003_02_f_2018_148				
Comment Code					
T1 : Trim trees to at least five feet above ground level.					
Inspector Comment					
Trim fig trees that are sprouting.

View of newly sprouting fig trees on the landside slope (October 2018).

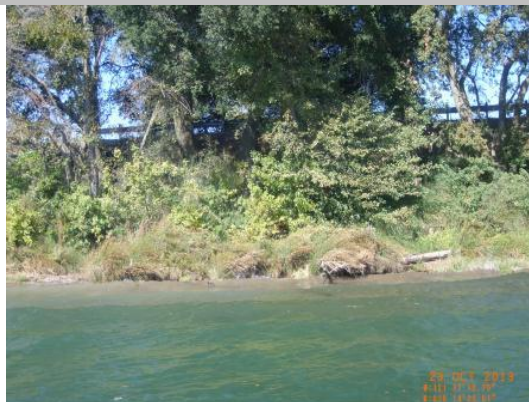
Photo 2 of 3 : SP\_2019\_RD0003\_25\_118\_20190311\_00081.jpg

LM Start	11.33	Rating **	M	Issue No.	118
LM End	11.41	Issue Type +	Ma	Location *	WS
Category	Supplemental			GPS Latitude/Longitude	
				Start	End
Item	2017 USACE Erosion Survey, DRAFT			38.239870 °	38.239992 °
				-121.520989 °	-121.519542 °
DWR ID	DWR_RD0003_02_f_2018_118				
Comment Code					
Inspector Comment					
2017 Site ID: SAC 26.3 R					
Status: Repaired					
2018: Still pocket of erosion into waterside toe.					
2017 Field Notes: Repaired by locals.					
Site History: 2009 - Hole left in levee toe from a fallen tree. Could be repaired under maintenance. 2010 - Minor new erosion. 2015 - Minor new erosion at toe.

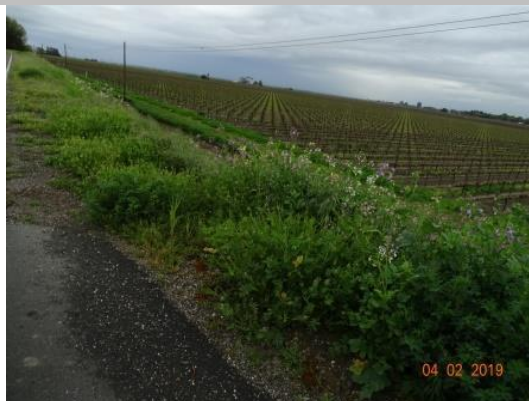
Photo 1 of 2 : SP\_2019\_RD0003\_25\_115\_20190404\_00325.jpg

LM Start	12.04	Rating **	M	Issue No.	115	
LM End	17.21	Issue Type +	Ma	Location *	LS	
Category	Earthen Levee			GPS Latitude/Longitude		
				Start		End
Item	Vegetation			38.246690 °		38.302622 °
				-121.511985 °		-121.572522 °
DWR ID	DWR_RD0003_02_s_2019_115					
Comment Code						
V1 : Control annual grass and weeds on the levee slopes and easements.						
Inspector Comment						
Control annual vegetation.

View looking downstream at annual vegetation on the landside slope (Spring 2019).

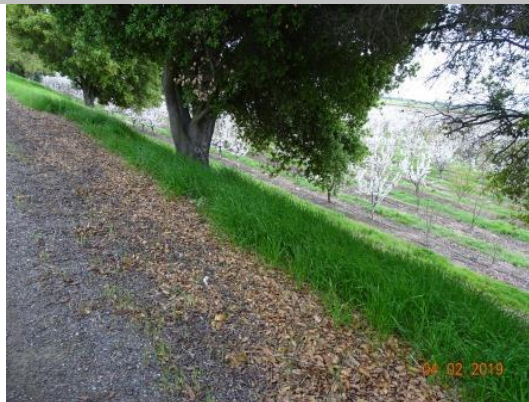
Photo 2 of 2 : SP\_2019\_RD0003\_25\_115\_20190404\_00326.jpg

View looking downstream at annual vegetation on the landside slope (Spring 2019).

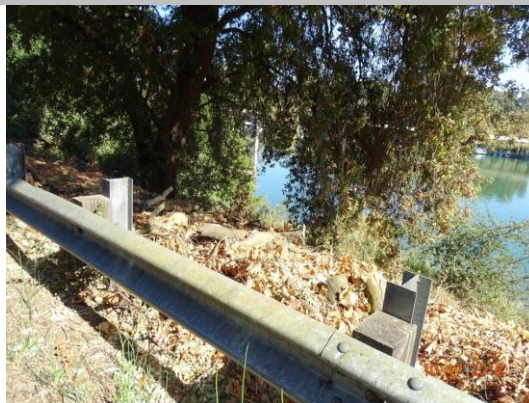
Photo 1 of 1 : SP\_2019\_RD0003\_25\_203\_20190311\_00159.jpg

LM Start	12.33	Rating **	M	Issue No.	203
LM End	12.33	Issue Type +	Ma	Location *	WS
Category	Earthen Levee			GPS Latitude/Longitude	
				Start	End
Item	Encroachments			38.250887 °	38.250887 °
				-121.512157 °	-121.512157 °
DWR ID	DWR_RD0003_02_f_2018_203				
Comment Code					
PR : Prunings					
Inspector Comment					
Remove prunings on the waterside hinge point.

View of prunings on the waterside shoulder (October 2018).

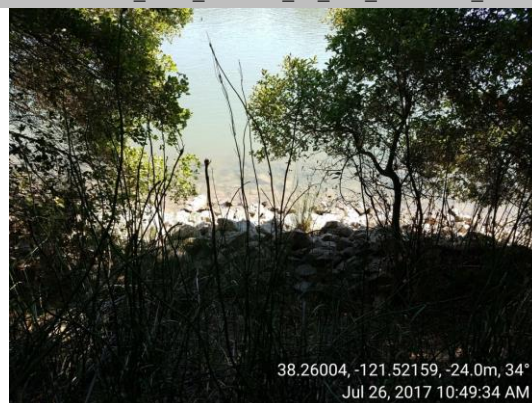
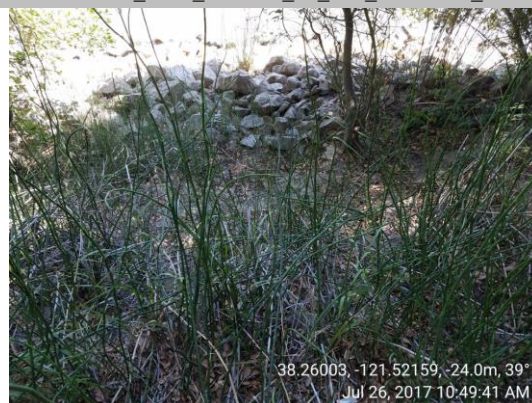
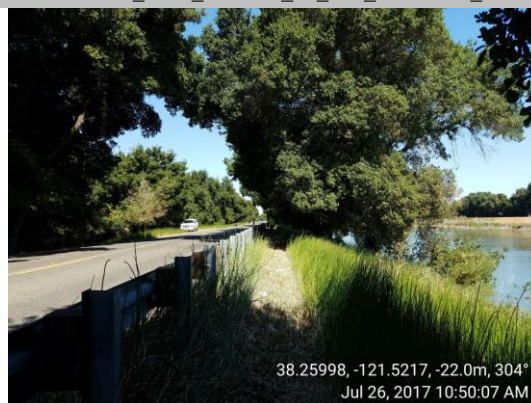
LM Start	13.15	Rating **	A/W	Issue No.	139
LM End	13.17	Issue Type +	Ma	Location *	
Category	Supplemental			GPS Latitude/Longitude	
				Start	End
Item	2017 Storm Damage			38.260042 °	38.260219 °
				-121.521581 °	-121.521803 °
DWR ID	DWR_RD0003_02_f_2017_139				
Comment Code					
Inspector Comment					
Levee Evaluation Comments					
Description: District station 694+80 to 695+69, Sec. 27, 1. 5 N. R. 4 E., M.D.M. Approximately 89 linear feet of erosion and sloughing exists along the water side slope of the Sacramento River (Unit 2). The erosion commences approximately 1/2 of the way down the slope from the crown and extends into the rip rap.					
Site ID No: 281					
Site Designation: LMA-107					
Repair Type: Erosion					
Rating: Area of Concern					
Field Date: 7/26/2017					
Notes:

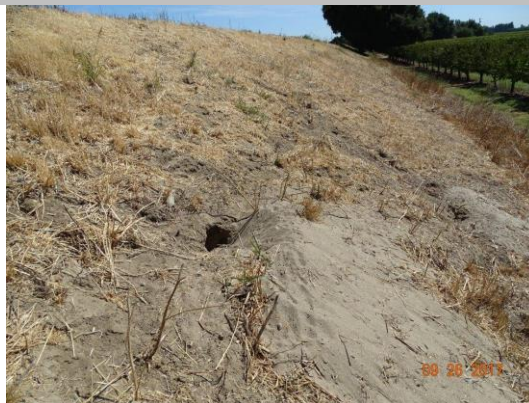
Photo 1 of 1 : SP\_2019\_RD0003\_25\_169\_20190311\_00145.jpg

LM Start	13.86	Rating **	A/W	Issue No.	169
LM End	13.86	Issue Type +	Ma	Location *	LS
Category	Earthen Levee			GPS Latitude/Longitude	
				Start	End
Item	Animal Control			38.267084 °	38.267084 °
				-121.530939 °	-121.530939 °
DWR ID	DWR_RD0003_02_f_2017_169				
Comment Code					
A1 : Exterminate rodents and backfill and compact or grout burrows.					
Inspector Comment

Looking southeast at the landside slope.

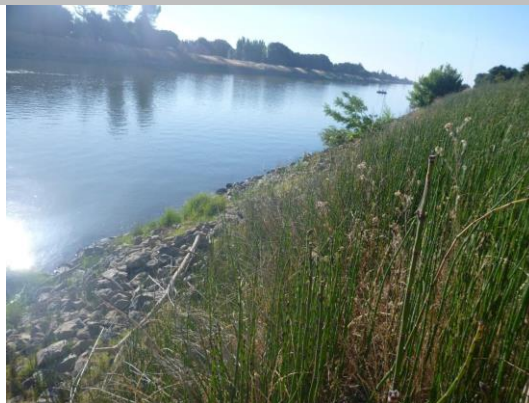
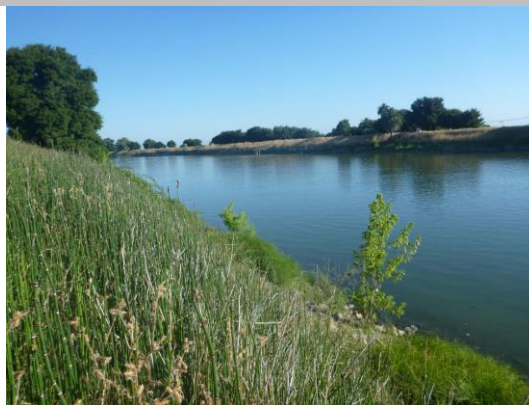
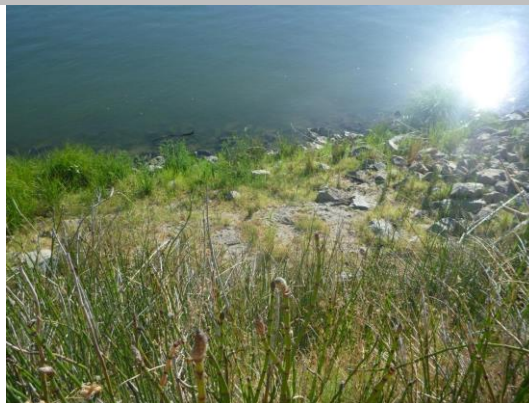
LM Start	15.00	Rating **	A/W	Issue No.	142
LM End	15.07	Issue Type +	Ma	Location *	
Category	Supplemental			GPS Latitude/Longitude	
				Start	End
Item	2017 Storm Damage			38.278806 °	38.279444 °
				-121.545817 °	-121.546647 °
DWR ID	DWR_RD0003_02_f_2017_142				
Comment Code					
Inspector Comment					
Levee Evaluation Comments					
Description:District station 792+44 to 795+74, Sec. 16, T. 5 N. R. 4 E., M.D.M. Approximately 330 linear feet of erosion and sloughing exists along the water side slope of the Sacramento River (Unit 2). The erosion commences approximately 1/2 of the way down the slope from the crown and extends into the rip rap.					
Site ID No:282					
Site Designation:LMA-108					
Repair Type: Erosion					
Rating:Area of Concern					
Field Date:7/28/2017					
Notes: no berm

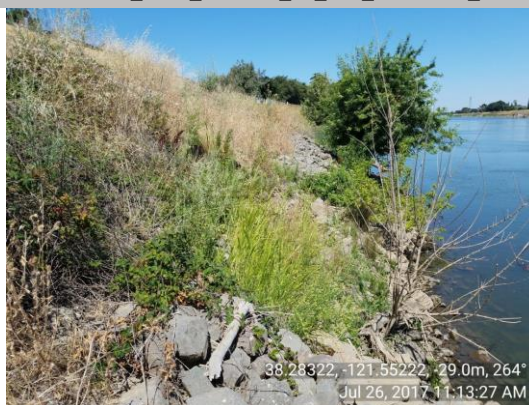
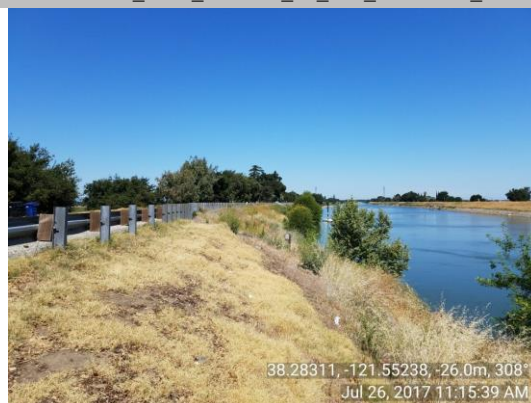
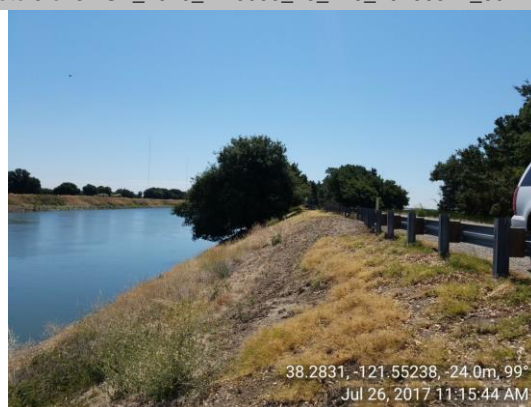
LM Start	15.46	Rating **	A/W	Issue No.	149
LM End	15.47	Issue Type +	Ma	Location *	
Category	Supplemental			GPS Latitude/Longitude	
				Start	End
Item	2017 Storm Damage			38.283119 °	38.283172 °
				-121.552250 °	-121.552347 °
DWR ID	DWR_RD0003_02_f_2017_149				
Comment Code					
Inspector Comment					
Levee Evaluation Comments					
Description:District station 816+64 to 816+97, Sec. 16, T. 5 N. R. 4 E., M.D.M. Approximately 33 linear feet of erosion exists along the water side slope of the Sacramento River (Unit 2). The erosion commences approximately 1/2 ofthe way down the slope from the crown and extends into the rip rap. A section of rip rap has eroded away in this location.					
Site ID No:283					
Site Designation:LMA-109					
Repair Type: Erosion					
Rating:Area of Concern					
Field Date:7/26/2017					
Notes:

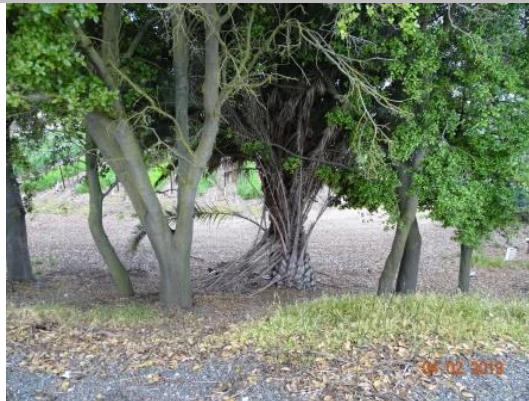
Photo 1 of 1 : SP\_2019\_RD0003\_25\_116\_20190404\_00327.jpg

LM Start	15.70	Rating **	M	Issue No.	116
LM End	15.70	Issue Type +	Ma	Location *	LS
Category	Earthen Levee			GPS Latitude/Longitude	
				Start	End
Item	Trim / Thin Trees			38.285349 °	38.285349 °
				-121.555548 °	-121.555548 °
DWR ID	DWR_RD0003_02_s_2019_116				
Comment Code					
T1 : Trim trees to at least five feet above ground level.					
Inspector Comment					
Remove fallen palm tree limbs.

View looking downslope at fallen palm limbs at the bottom of the landside slope (Spring 2019).

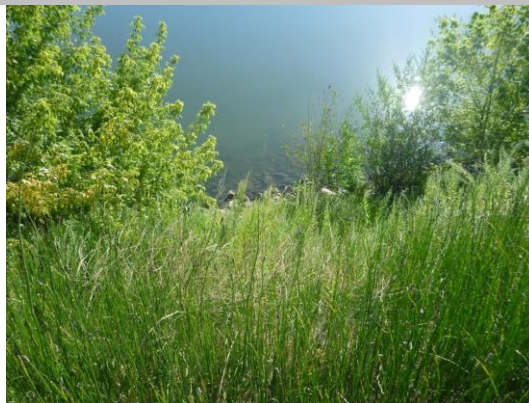
Photo 1 of 2 : SP\_2019\_RD0003\_25\_150\_20190311\_00126.jpg

LM Start	16.54	Rating **	A/W	Issue No.	150
LM End	16.56	Issue Type +	Ma	Location *	
Category	Supplemental			GPS Latitude/Longitude	
				Start	End
Item	2017 Storm Damage			38.294717 °	38.294986 °
				-121.565417 °	-121.565661 °
DWR ID	DWR_RD0003_02_f_2017_150				
Comment Code					
Inspector Comment					
Levee Evaluation Comments					
Description:District station 873+61 to 874+83, Sec. 08, T. 5 N. R. 4 E., M.D.M. Approximately 122 linear feet of erosion exists along the water side slope of the Sacramento River (Unit 2). The erosion commences approximately 1/2 of the way down the slope from the crown and extends beyond the rip rap. A section of rip rap has eroded away in this location.					
Site ID No:284					
Site Designation:LMA-110					
Repair Type: Erosion					
Rating:Area of Concern					
Field Date:7/28/2017					
Notes: no berm
